**Flood Control Project Maintenance  
Levee Inspections**

## Maintenance Issue Types Only, Levee Inspection Report By Mile - Spring 2019

### Sutter Maintenance Yard East-West Interceptor

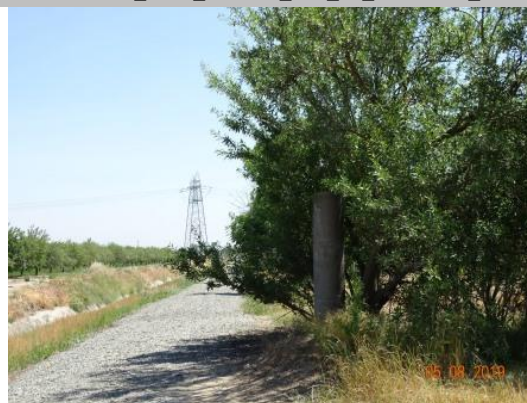
Photo 1 of 1 : SP\_2019\_ST0020\_213\_15\_20190510\_00031.jpg

LM Start	1.08	Rating **	M	Issue No.	15
LM End	1.08	Issue Type +	Ma	Location *	LS
Category	Earthen Levee			GPS Latitude/Longitude	
				Start	End
Item	Trim / Thin Trees			39.171284 °	39.171284 °
				-121.739879 °	-121.739879 °
DWR ID	DWR_ST0020_01_s_2019_15				
Comment Code					
T1 : Trim trees to at least five feet above ground level.					
Inspector Comment

View of the trees on the landside slope. Spring 2019.

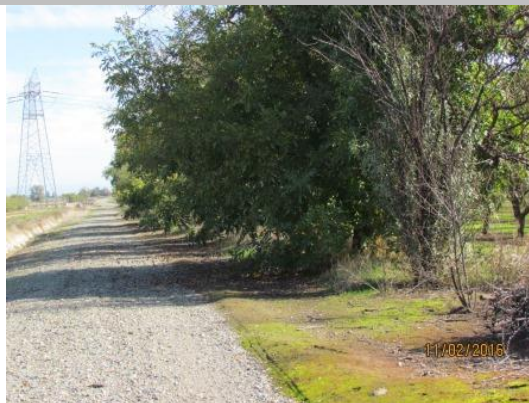
Photo 1 of 1 : SP\_2019\_ST0020\_213\_18\_20190327\_00011.jpg

LM Start	1.11	Rating **	M	Issue No.	18
LM End	1.28	Issue Type +	Ma	Location *	LS
Category	Earthen Levee			GPS Latitude/Longitude	
				Start	End
Item	Trim / Thin Trees			39.171283 °	39.171243 °
				-121.739315 °	-121.736312 °
DWR ID	DWR_ST0020_01_f_2016_18				
Comment Code					
T1 : Trim trees to at least five feet above ground level.					
Inspector Comment

View of the trees blocking visibility.

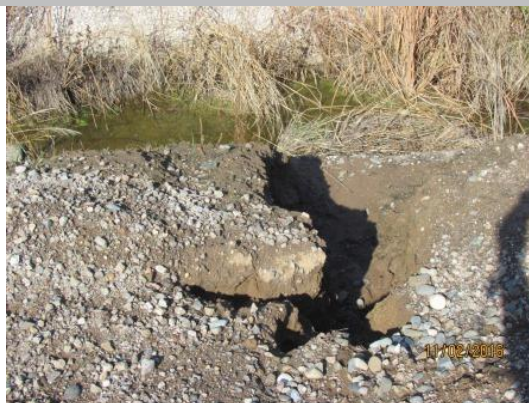
Photo 1 of 1 : SP\_2019\_ST0020\_213\_22\_20190327\_00014.jpg

LM Start	1.33	Rating **	M	Issue No.	22
LM End	1.33	Issue Type +	Ma	Location *	WS
Category	Earthen Levee			GPS Latitude/Longitude	
				Start	End
Item	Erosion / Bank Caving			39.171218 °	39.171218 °
				-121.735258 °	-121.735258 °
DWR ID	DWR_ST0020_01_f_2016_22				
Comment Code					
E1 : Note and monitor erosion site.					
Inspector Comment

View of the erosion along the bank.

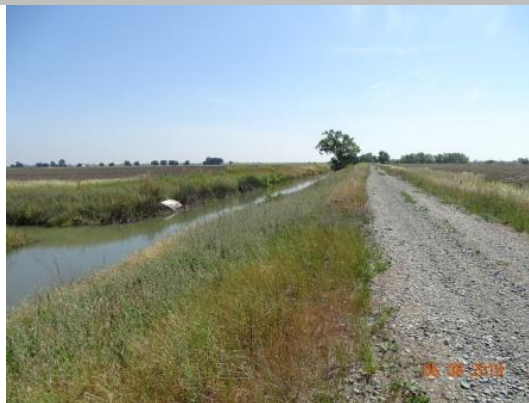
Photo 1 of 1 : SP\_2019\_ST0020\_214\_36\_20190510\_00085.jpg

LM Start	0.01	Rating **	U	Issue No.	36
LM End	2.03	Issue Type +	Ma	Location *	WS
Category	Earthen Levee			GPS Latitude/Longitude	
				Start	End
Item	Vegetation			39.171155°	39.170675°
				-121.726179°	-121.688769°
DWR ID	DWR_ST0020_02_s_2019_36				
Comment Code					
V1 : Control annual grass and weeds on the levee slopes and easements.					
Inspector Comment

View of the vegetation on the waterside slope. Spring 2019.

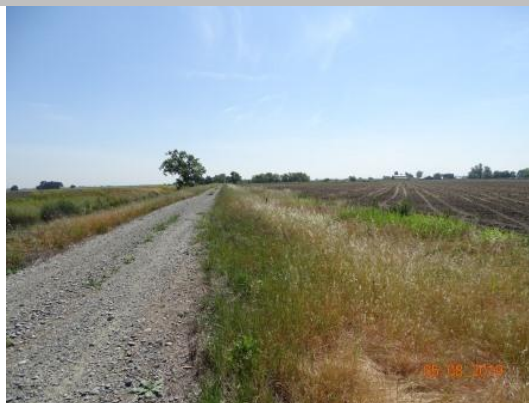
Photo 1 of 1 : SP\_2019\_ST0020\_214\_37\_20190510\_00086.jpg

LM Start	0.01	Rating **	U	Issue No.	37
LM End	1.51	Issue Type +	Ma	Location *	LS
Category	Earthen Levee			GPS Latitude/Longitude	
				Start	End
Item	Vegetation			39.171156 °	39.170767 °
				-121.726176 °	-121.698430 °
DWR ID	DWR_ST0020_02_s_2019_37				
Comment Code					
V1 : Control annual grass and weeds on the levee slopes and easements.					
Inspector Comment

View of the vegetation on the landside slope. Spring 2019.

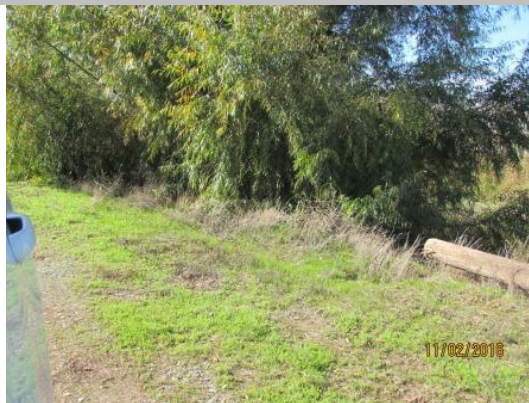
Photo 1 of 1 : SP\_2019\_ST0020\_214\_31\_20190327\_00013.jpg

LM Start	0.29	Rating **	M	Issue No.	31
LM End	0.32	Issue Type +	Ma	Location *	WS
Category	Earthen Levee			GPS Latitude/Longitude	
				Start	End
Item	Trim / Thin Trees			39.171008°	39.171090°
				-121.721025°	-121.720487°
DWR ID	DWR_ST0020_02_f_2016_31				
Comment Code					
T1 : Trim trees to at least five feet above ground level.					
Inspector Comment

View of the overgrown trees blocking visibility and access.

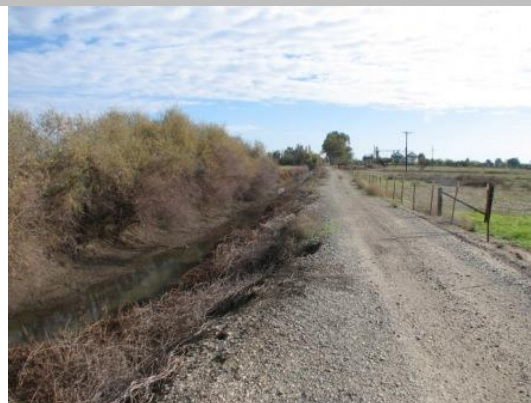
Photo 1 of 2 : SP\_2019\_ST0020\_214\_4\_20190327\_00003.jpg

LM Start	1.54	Rating **	M	Issue No.	4
LM End	2.01	Issue Type +	Ma	Location *	WS
Category	Earthen Levee			GPS Latitude/Longitude	
				Start	End
Item	Erosion / Bank Caving			39.170800 °	39.170732 °
				-121.698105 °	-121.689082 °
DWR ID	DWR_NA0020_02_s _ 2012_4				
Comment Code					
E1 : Note and monitor erosion site.					
Inspector Comment					
Monitor the erosion along the waterside slope.

View of the erosion along the waterside slope.

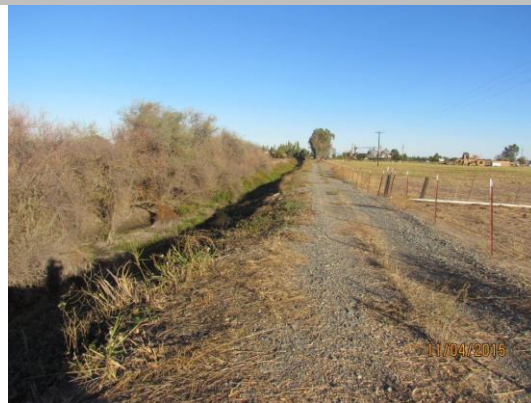
Photo 2 of 2 : SP\_2019\_ST0020\_214\_4\_20190327\_00004.jpg

LM Start	<b>1.54</b>	Rating **	M	Issue No.	<b>4 (cont)</b>
LM End	<b>2.01</b>	Issue Type +	Ma	Location *	WS

View of the erosion along the waterside slope.

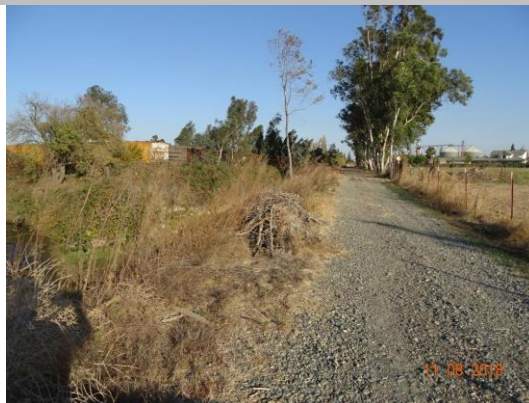
Photo 1 of 1 : SP\_2019\_ST0020\_214\_18\_20190327\_00008.jpg

LM Start	1.68	Rating **	M	Issue No.	18
LM End	1.68	Issue Type +	Ma	Location *	WS
Category	Earthen Levee			GPS Latitude/Longitude	
				Start	End
Item	Encroachments			39.170810 °	39.170810 °
				-121.695342 °	-121.695342 °
DWR ID	DWR_ST0020_02_f_2018_18				
Comment Code					
DE : Debris					
Inspector Comment					
Remove the debris from the waterside berm.

View of the debris along the waterside berm.

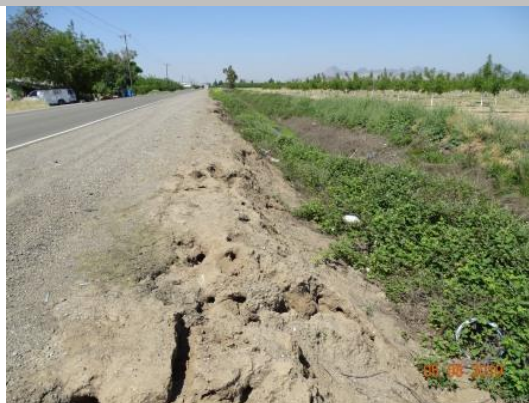
Photo 1 of 1 : SP\_2019\_ST0020\_214\_38\_20190510\_00087.jpg

LM Start	2.72	Rating **	U	Issue No.	38
LM End	2.72	Issue Type +	Ma	Location *	WS
Category	Earthen Levee			GPS Latitude/Longitude	
				Start	End
Item	Animal Control			39.170624 °	39.170624 °
				-121.675992 °	-121.675992 °
DWR ID	DWR_ST0020_02_s_2019_38				
Comment Code					
A3 : No rodents visible, but rodent burrows visible; need to backfill and compact or grout burrows.					
Inspector Comment					
Significant rodent activity is present. The surface runoff is further eroding the waterside shoulder/slope.

View of significant rodent activity on the waterside slope. Spring 2019.
